# Evaluation of Pollution Abatement Alternatives Picillo Property, Coventry, Rhode Island

EPA-600/2-81-186
September 1981

# EVALUATION OF POLLUTION ABATEMENT ALTERNATIVES: PICILLO PROPERTY, COVENTRY, RHODE ISLAND

The MITRE Corporation
Metrek Divison
Bedford, Massachusetts 01730

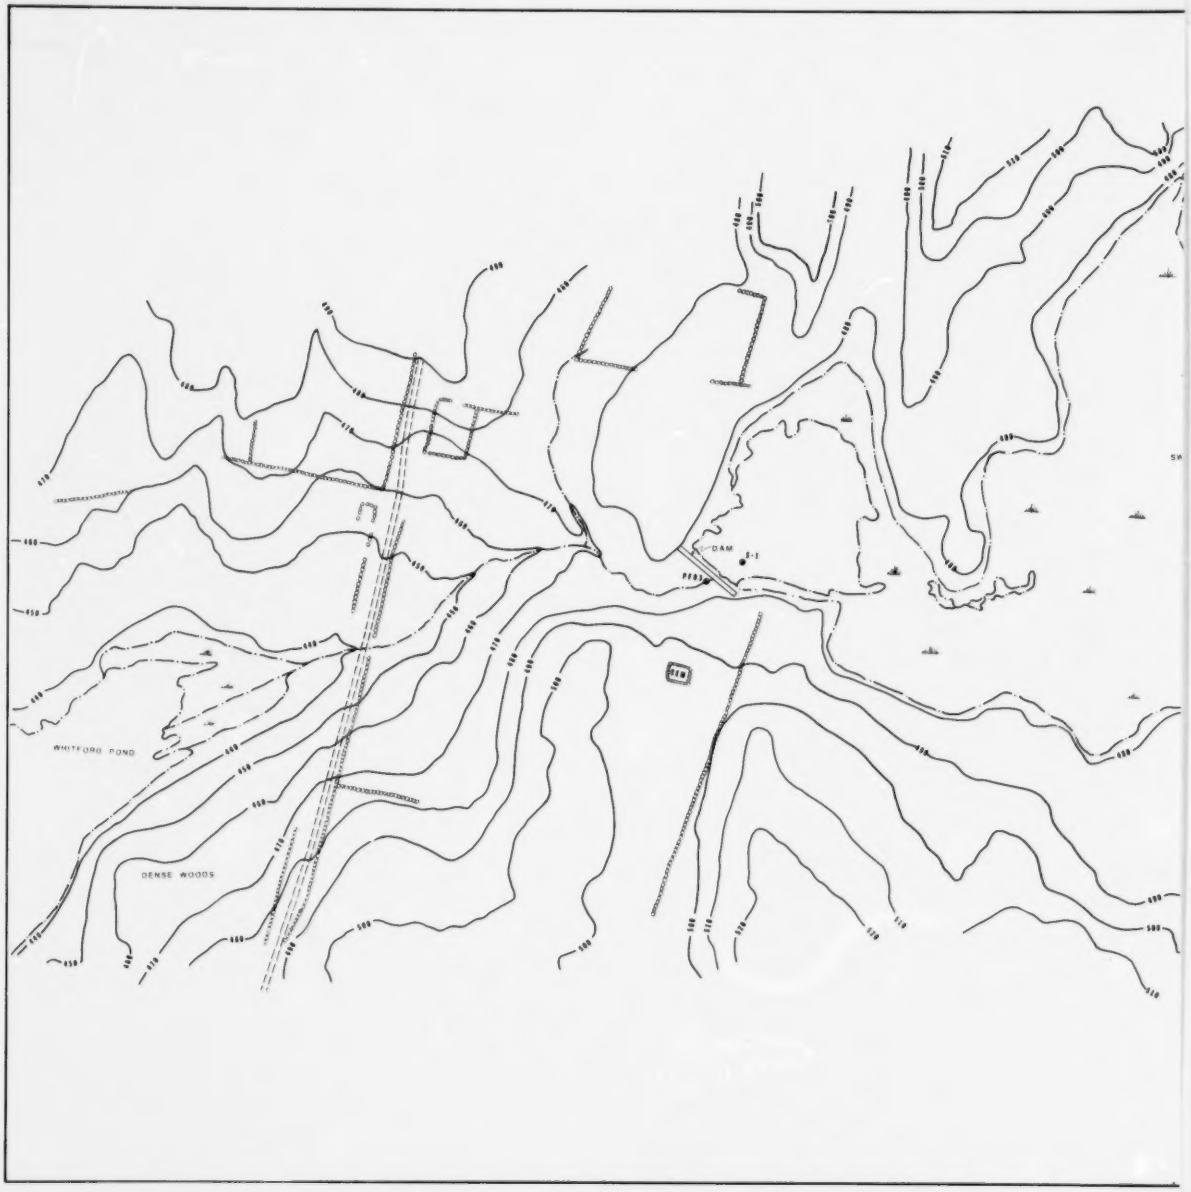
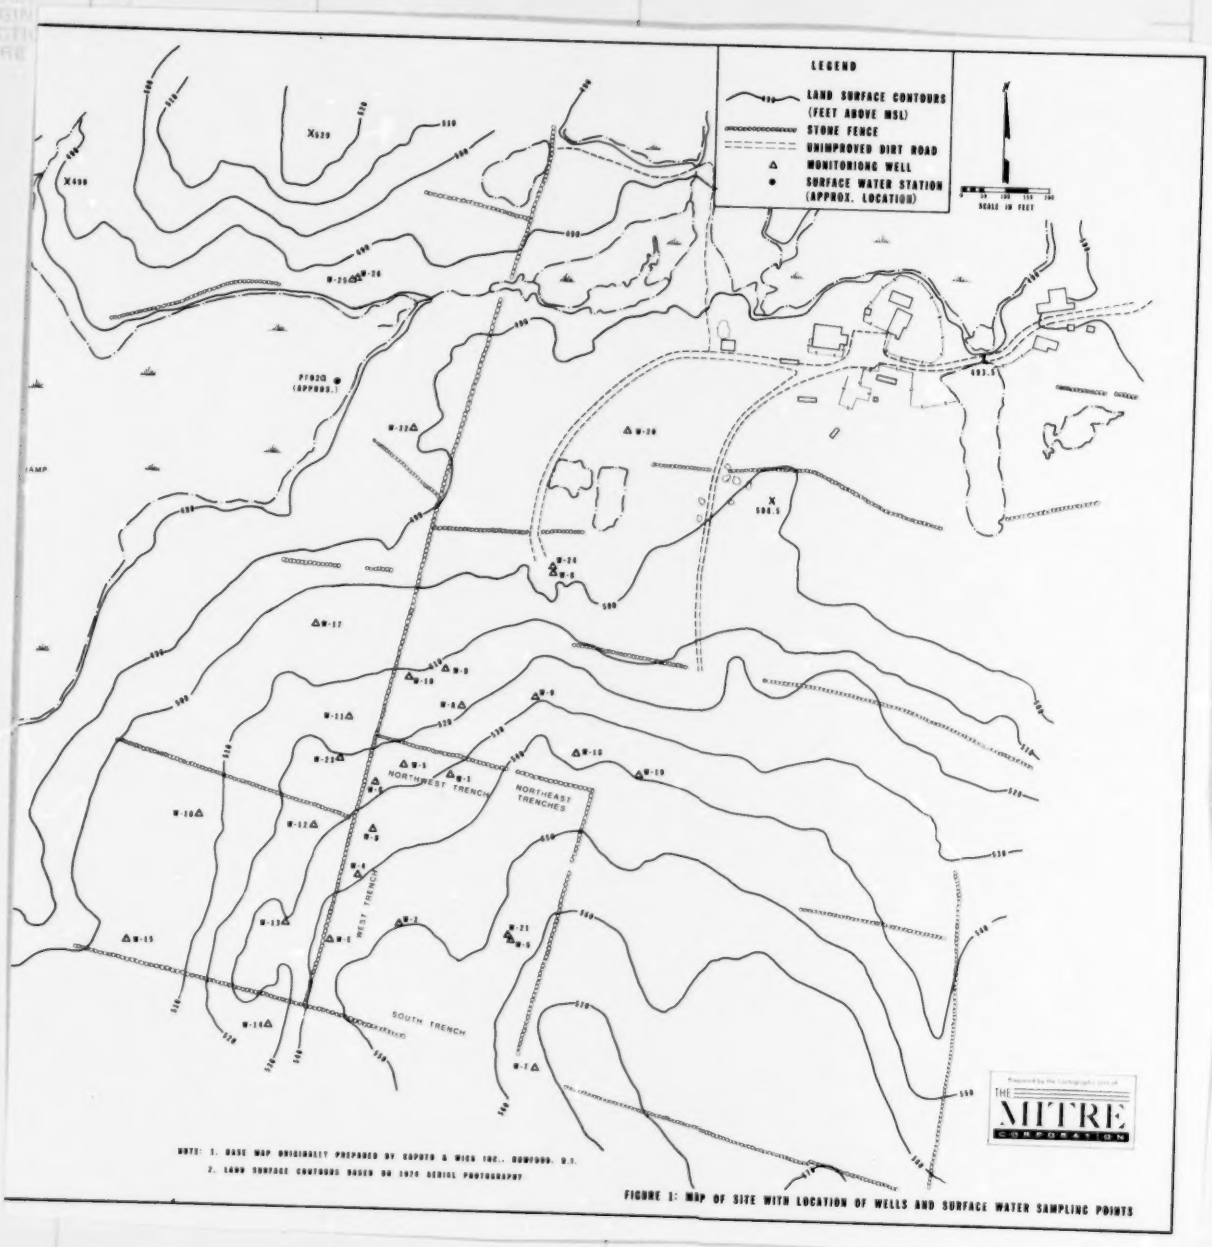
FIGURE 1: MAP OF SITE WITH LOCATION OF WELLS AND SURFACE WATER SAMPLING POINTS

The results of organic chemical analysis performed on soils and surface and ground waters are presented in Tables 11, 12, and 13. The locations of all sampling stations are shown on Figure 1.

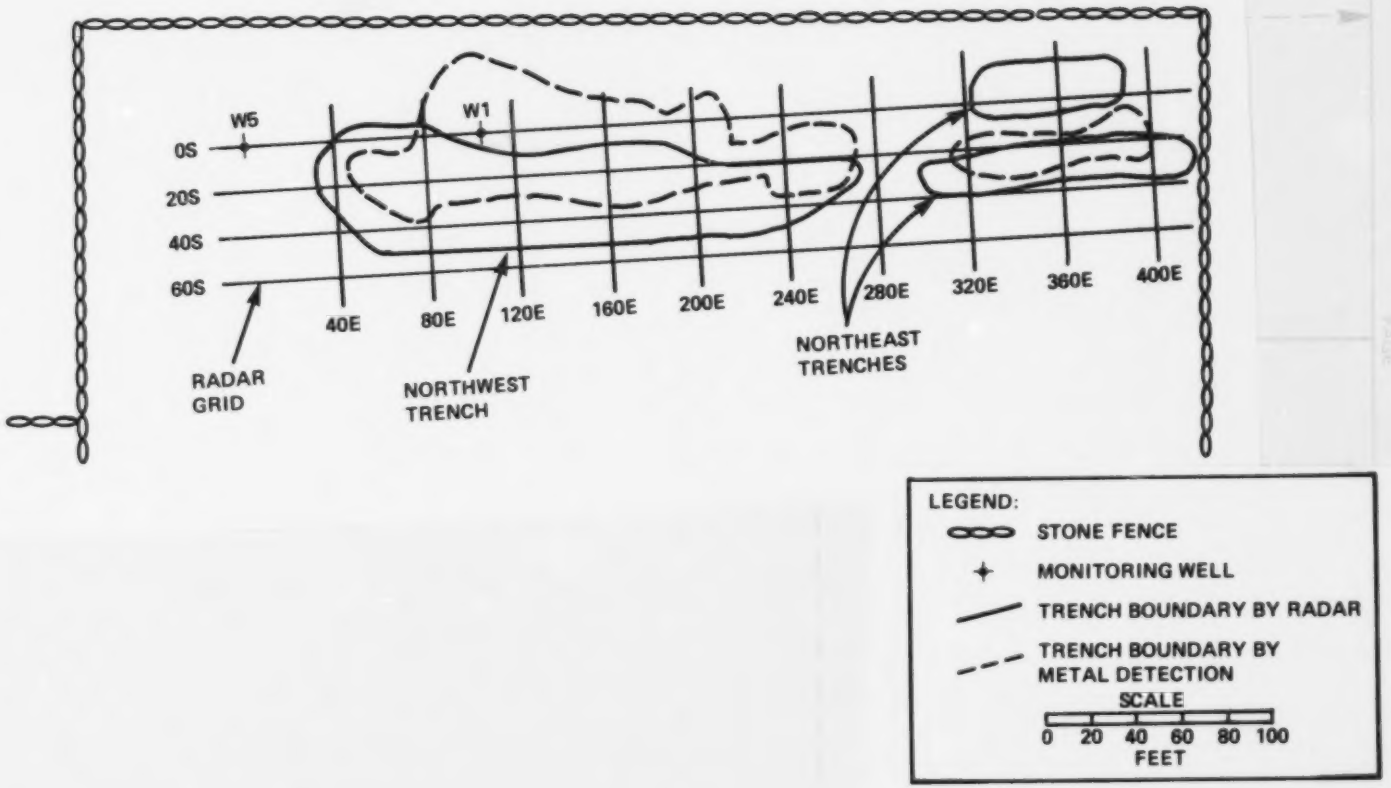
Figure 2. Comparison of Northeast and Northwest Trench Locations as Detected by Ground-Penetrating Radar and Metal Detection
(Grid based on locations of W5 and W1)

presented as reported by the subcontractors who conducted the field surveys. Although there is not complete overlap between the outlines determined by the two methods, it is suspected that the deviation is due mainly to inaccuracies in the reporting of the metal detection results. However, it is recommended that the trench boundaries as determined by metal detection be accepted until their validity is either proven or disproven by actual excavation. Since the radar probed to a depth of 12 ft in contrast to the four to six feet for metal detection, the radar would be expected to present a somewhat more accurate indication of trench boundaries. Trench boundaries from the two techniques were compared for all trenches. The radar found two trenches in the "Northeast Trench", versus the single trench identified earlier with metal detection. On the other hand, the radar data for the West Trench proved to give incomplete areal coverage and therefore were supplemented by data from the metal detection.

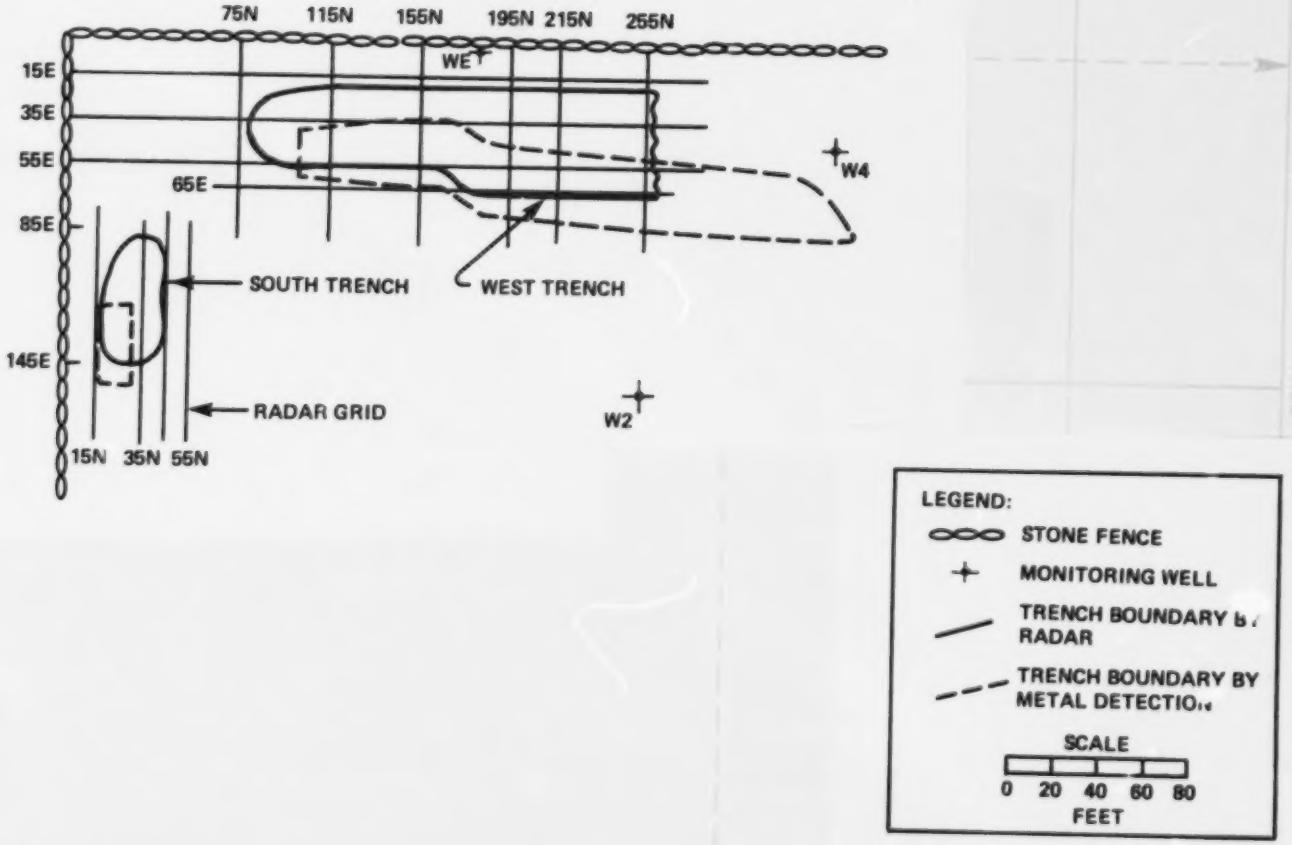
Figure 3. Location of South and West Trenches as Determined by Ground-Penetrating Radar and Metal Detection (Grid based on locations of south and west stone fences)

The radar was able to detect five areas of liquid plumes within trenches. This was possible because of the higher dielectric constant of the fluid relative to the ground water. As described in the preceding subsection, the plumes were actually nested pockets of chemicals. The location of the trenches as determined by ground-penetrating radar are shown in Appendix B.

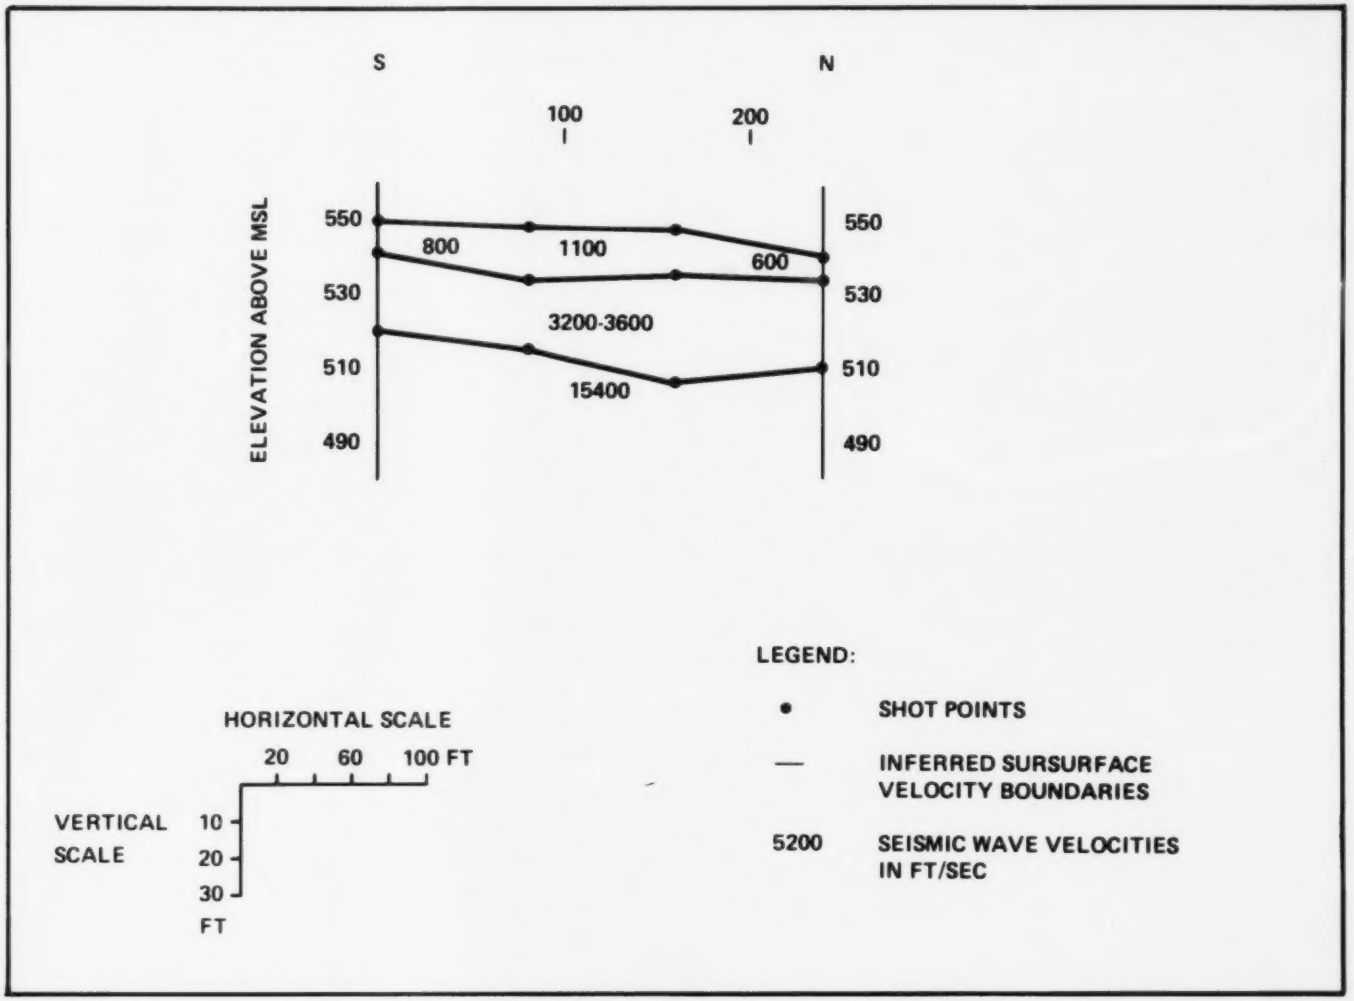
The seismic refraction survey conducted over the West Trench indicated that drums were buried to a maximum depth of 14 feet, but since this was an experimental application of the process, the results may not be used without qualification until the method has been field verified. Figure 4 presents the subsurface profile of the West Trench based upon the results of the seismic work. The tentative drum burial area appears on the figure as a region with seismic velocities between 600 and 1100 feet per second (fps); such velocities are typical of loose or unconsolidated soil or fill. There is a sharp distinction between this zone and the one directly underneath having velocities between 3200 and 3600 fps. The velocities of the second zone are typical of non-saturated sands and gravels or compacted fills. Because this zone extends below the water table, it is interpreted that the buried drums end at 14 ft, the interface between the two zones. The lowest zone with a velocity of 15,400 fps represents the underlying bedrock.

Figure 4. Subsurface Profile of the West Trench as Determined by Seismic Refraction (Ground surface represented by top line of figure)

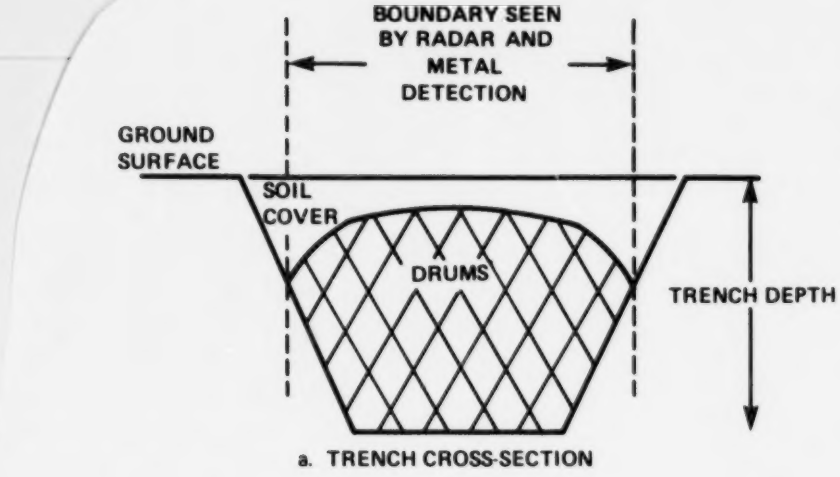
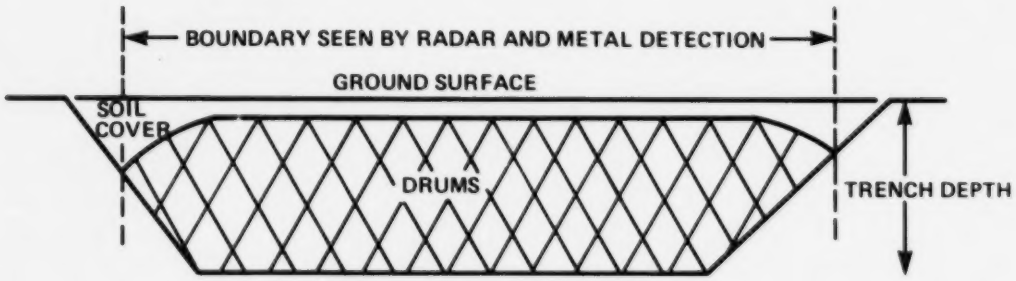
Figure 5. Illustrative Trench Geometry

In order to produce estimates for the number of drums remaining buried, a theoretical trench geometry shown by Figure 5 was employed. The angle of the vertical side walls was assumed to be 60°, the angle of the declining surface of drums 45°, and the angle of descent at the trench ends 45°. The angle of repose for disturbed site soil is approximately 45°, but the excavated side walls can maintain a much steeper slope. Table 5 compares the geometrical assumptions used for the drum number estimates produced from the Phase I and Phase II investigations.

Two densities of drums (percent of volume of drums within trench volume below the cover layer of soil) were used for the drum number estimates: 90 percent and 50 percent. A drum density of 90 percent represents the closest packing arrangement possible for cylinders without regard to interferences imposed by the actual geometry of the trench boundaries. An actual drum density of 54 percent was calculated for the Northeast Trenches using the results** obtained from the DEM Site-Representative combined with the theoretical geometry shown by Figure 5. The calculated 54 percent density was rounded off to 50 percent for the lower limit calculations of the drum number estimates.

Random stacking indicated by results of excavation of Northeast Trenches, approximated by 50 percent drums, 50 percent earth by volume in trench below 2-foot cover and assumed trench geometry, as shown by Figure 5.

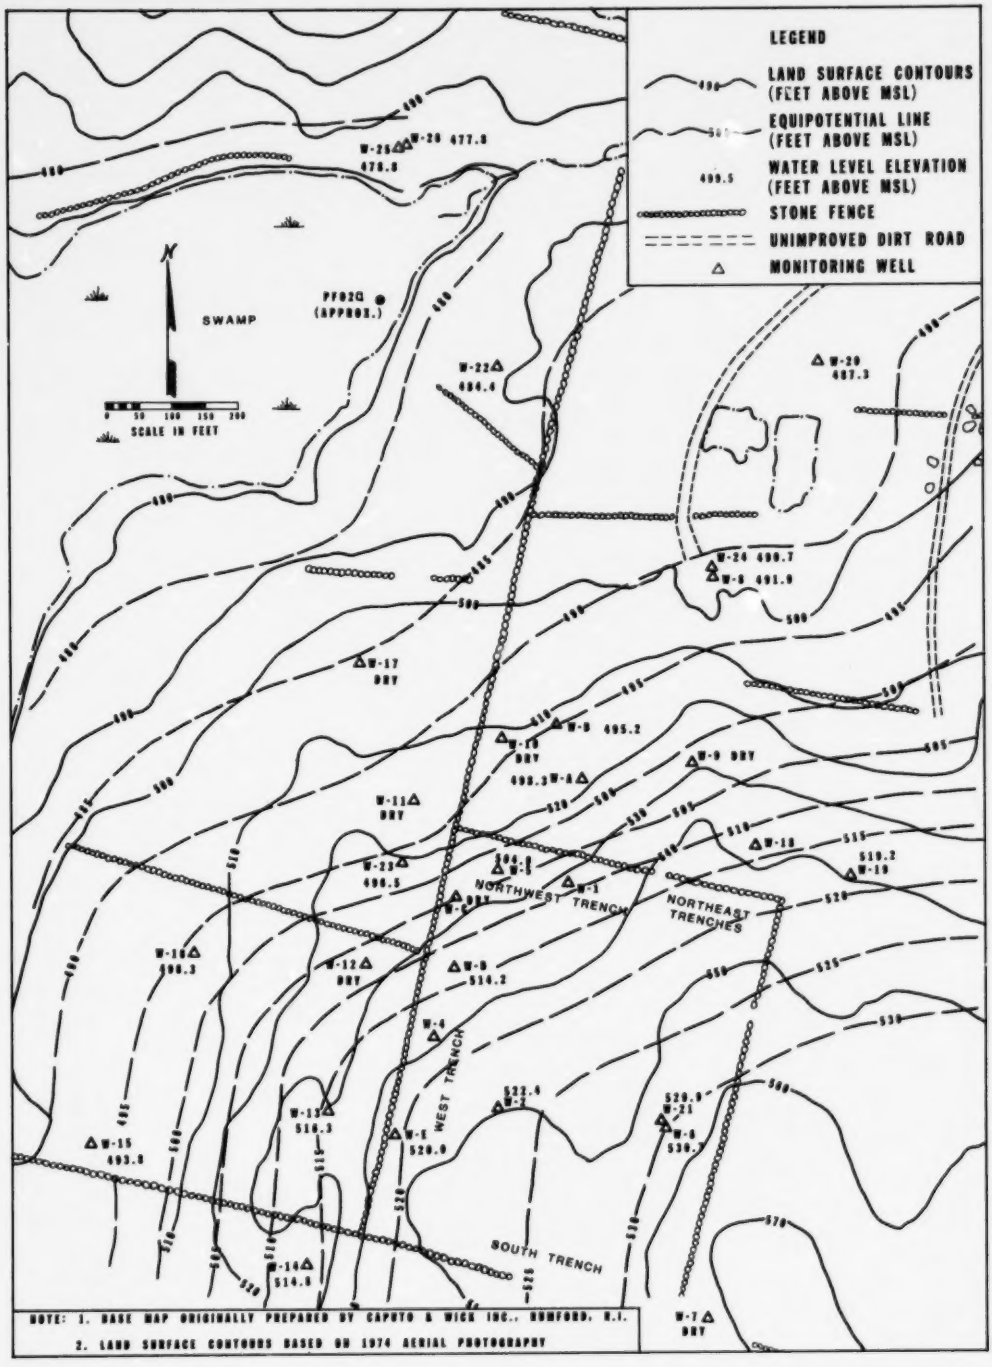
Measurements of the water level in all the wells were taken on August 12, 1980 and used to prepare Figure 6. (Appendix C contains a monthly plot of the water level below ground surface since January for several wells at the site.) Horizontal ground water flow is perpendicular to the equipotentials (lines of equal water level elevation) shown on the figure. Missing from the map is the area of no ground water flow, which had been part of the January 14, 1980 water level map presented in the Phase I report.

The Phase I resistivity values obtained for the northwest corner were higher than other regions of the site, indicating little conductive ground water contamination. It was thought that a mound in the bedrock caused a diversion of contaminated ground water away from this area. The high resistivity values now seem to have been the result of the depth of the saturated zone, since the ground water sample from W23 showed a relatively high concentration of contaminants (see following subsection for results of chemical analysis). The depth to the water table off the northwest corner is approximately 24 ft, while it varies from less than 5 ft to almost 17 ft in other regions surrounding the site.

Figure 6 additionally shows that the direction of ground water flow on the north side of the swamp is toward the swamp. Consequently, the existence of swamp underflow of contaminants is unlikely.

Figure 6. Water Table Map for August 12, 1980

The water table map shown by Figure 6 indicates that the swamp is the sole discharge area for contamination leaving the dump site. Although the downward gradient in the cluster well near the swamp is slight, the possibility for downward migration of some of the contaminants (and subsequent transport beyond the swamp) cannot be discounted. For this reason it is recommended that a monitoring well screened in the bedrock be installed between the swamp and Whitford Pond.

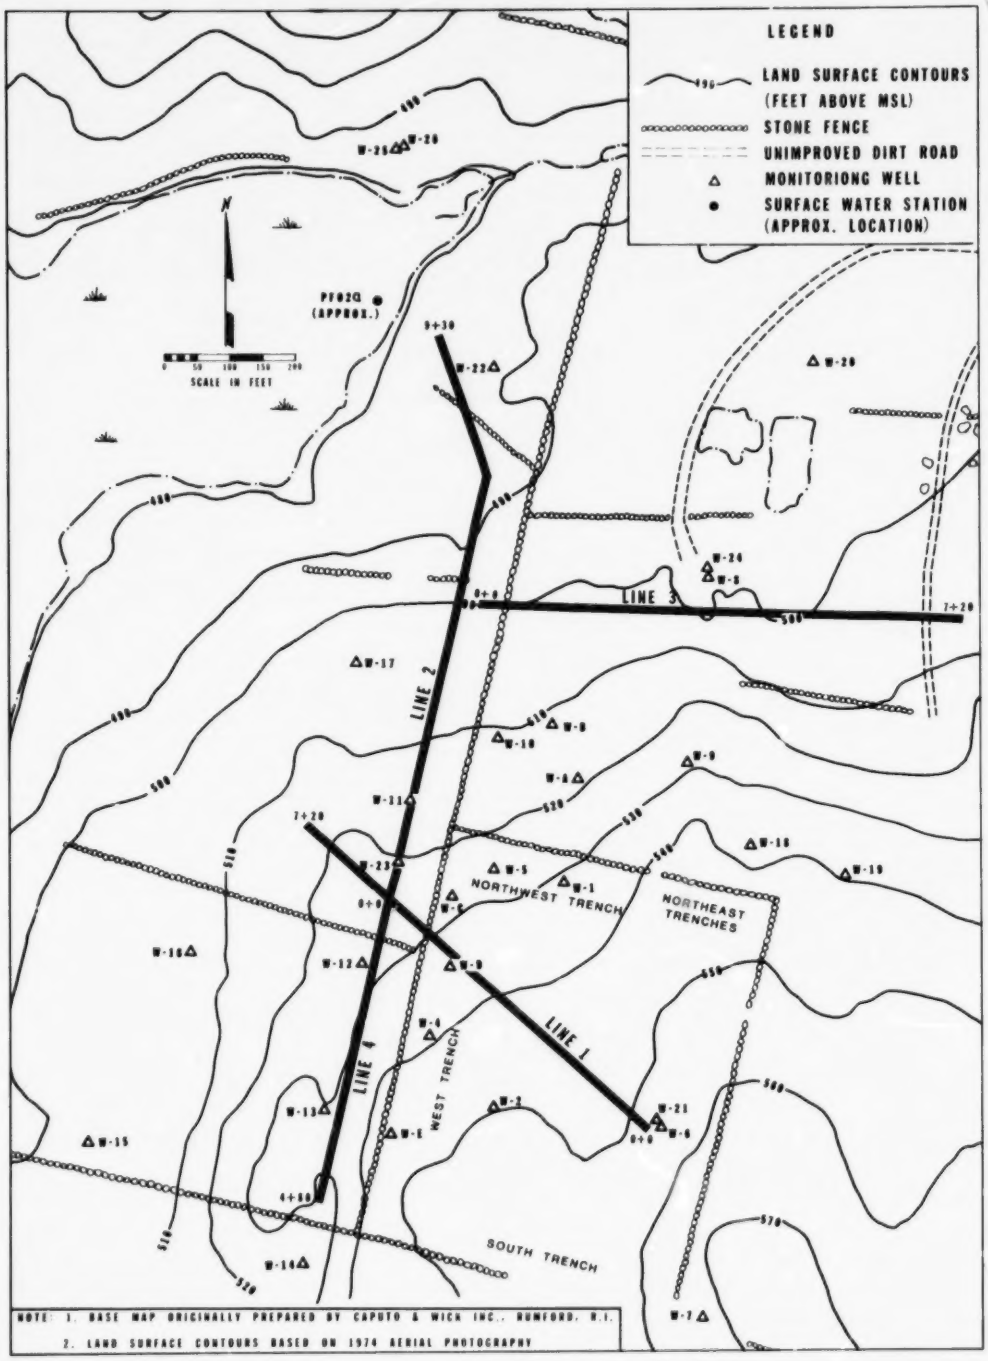
Figure 7. Location of Seismic Refraction Profiles
(Note: Profile locations are approximate only
and are not based on survey results.)

The locations of the seismic profiles in relation to the site are shown on Figure 7. It should be noted that these profiles were not surveyed and their locations are only approximated in Figure 7. Figures 8 to 11 present the results of the seismic refraction survey, and Table 8 provides correlations between seismic velocities and various geologic strata. Although the seismic profiles crossing the northwest region (lines 1 and 2) do not show the presence of a mound in the bedrock, the depression that exists at the 400 ft location of line 1 (in the region of well WD) and subsequent rise toward the northwest corner may account for the thin saturated zone and contamination of the bedrock (as described in the following subsection).

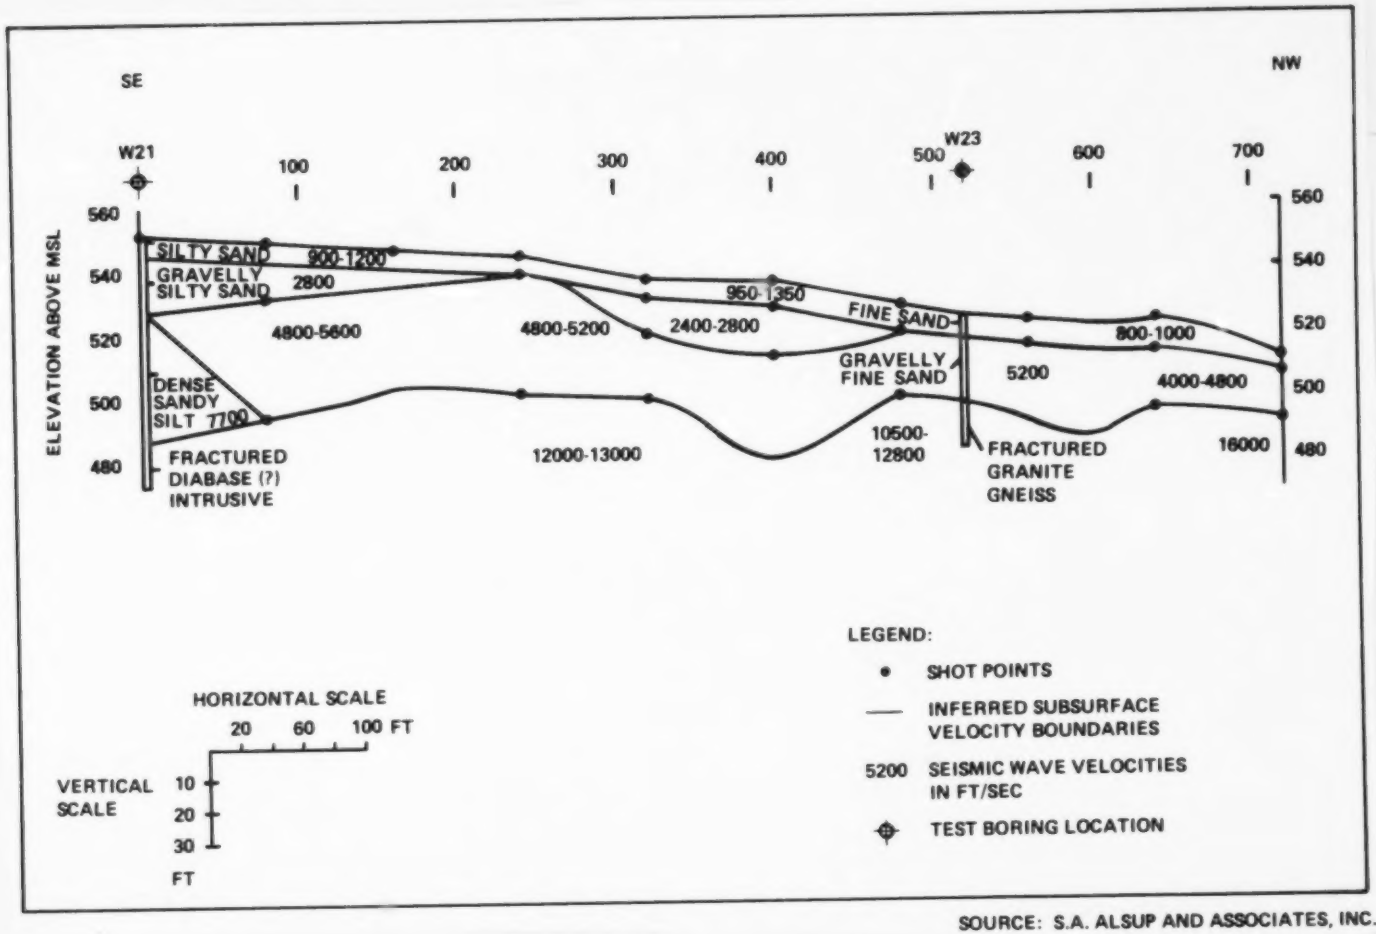
Figure 8. Results of Seismic Refraction Survey: Line 1
(Ground surface represented by top line of figure)

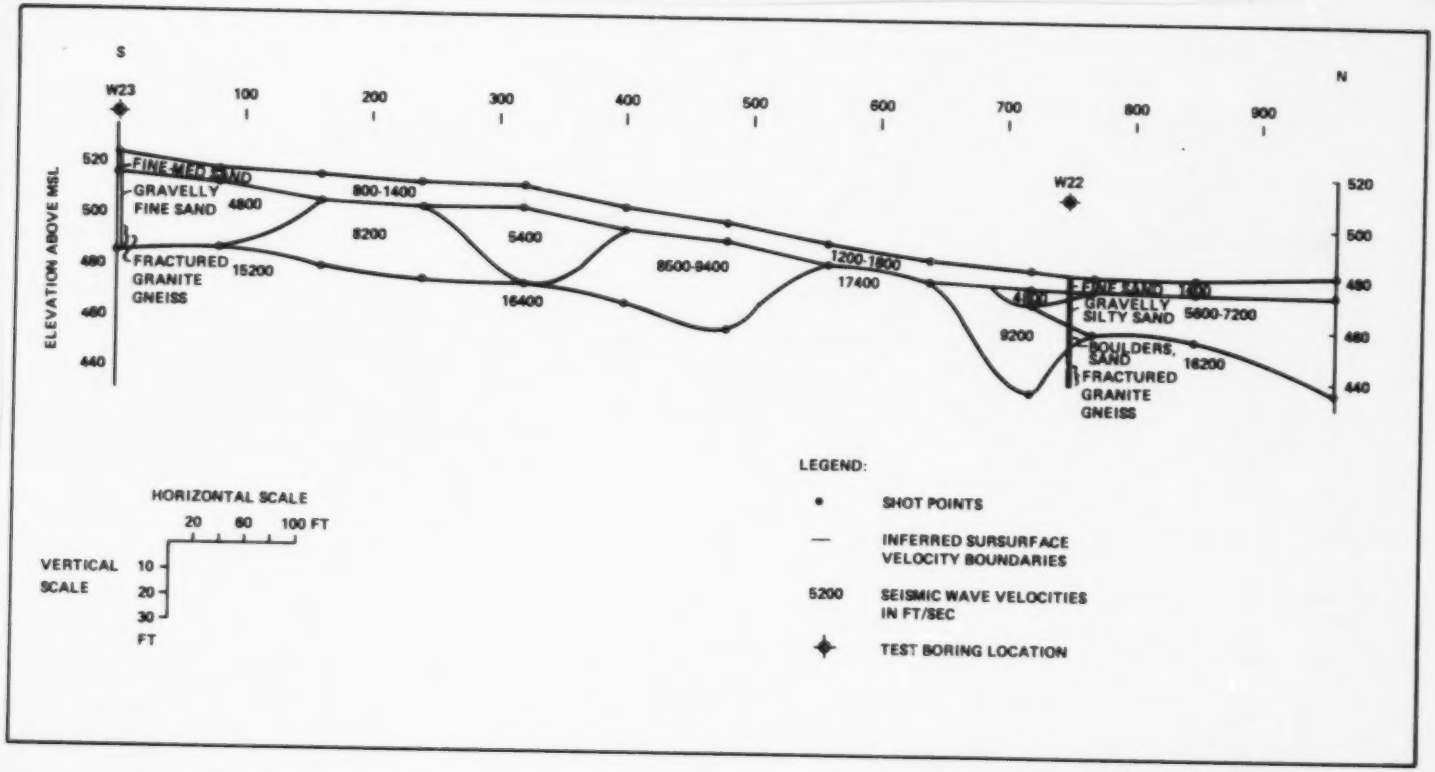
Figure 9. Results of Seismic Refraction Survey: Line 2
(Ground surface represented by top line of figure)

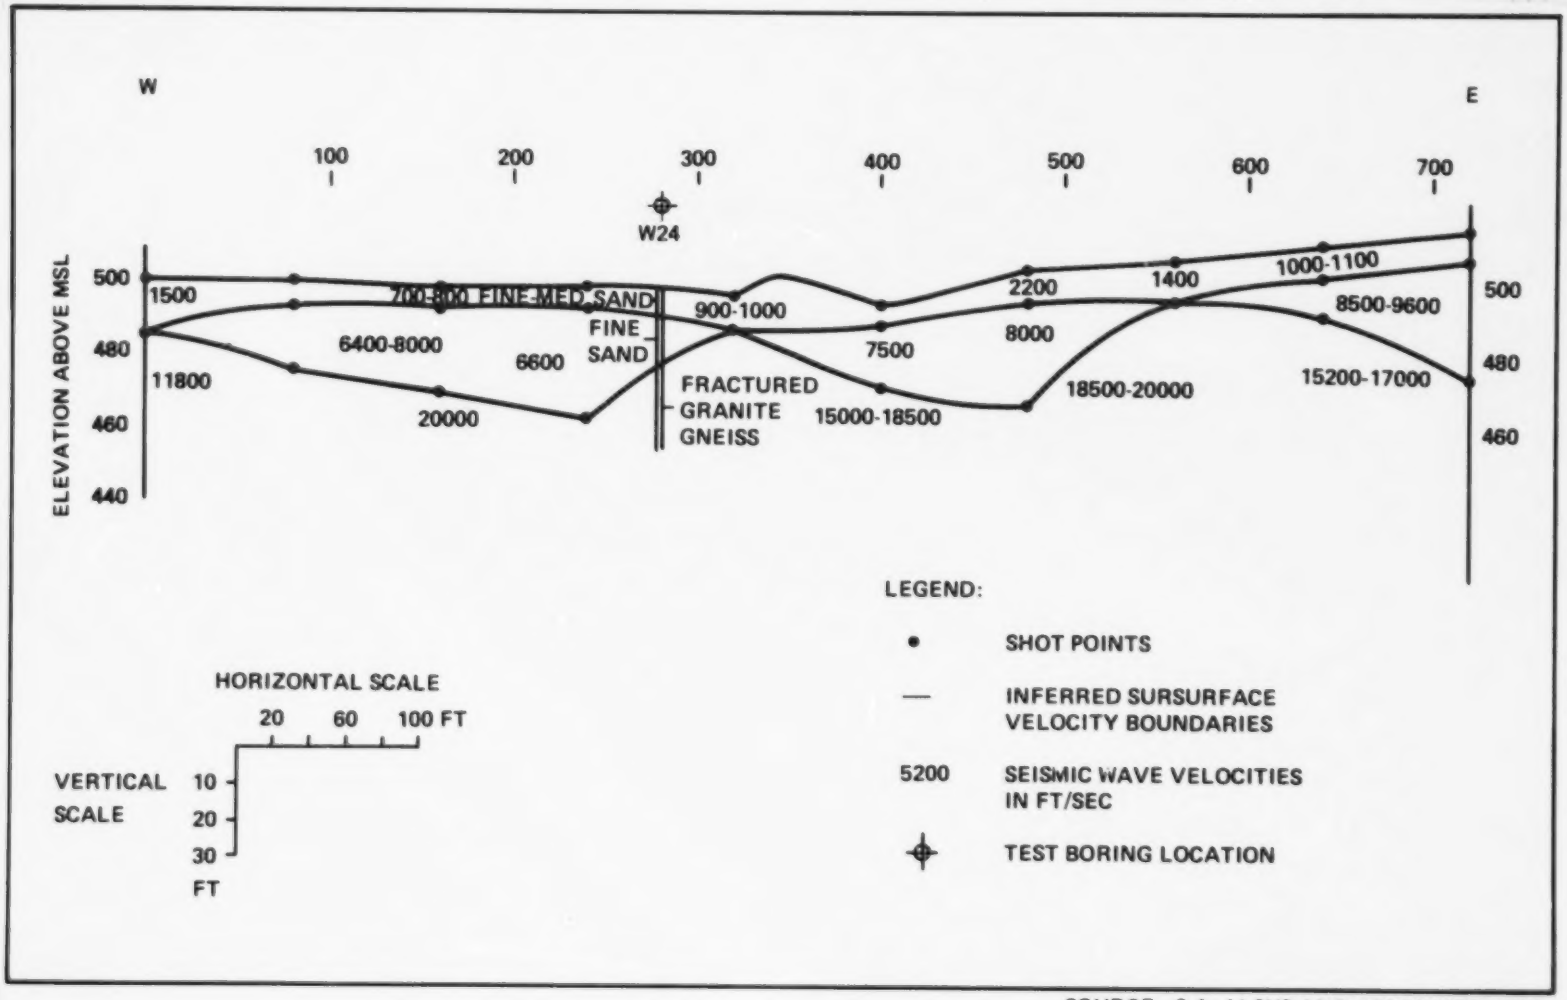
Figure 10. Results of Seismic Refraction Survey: Line 3
(Ground surface represented by top line of figure)

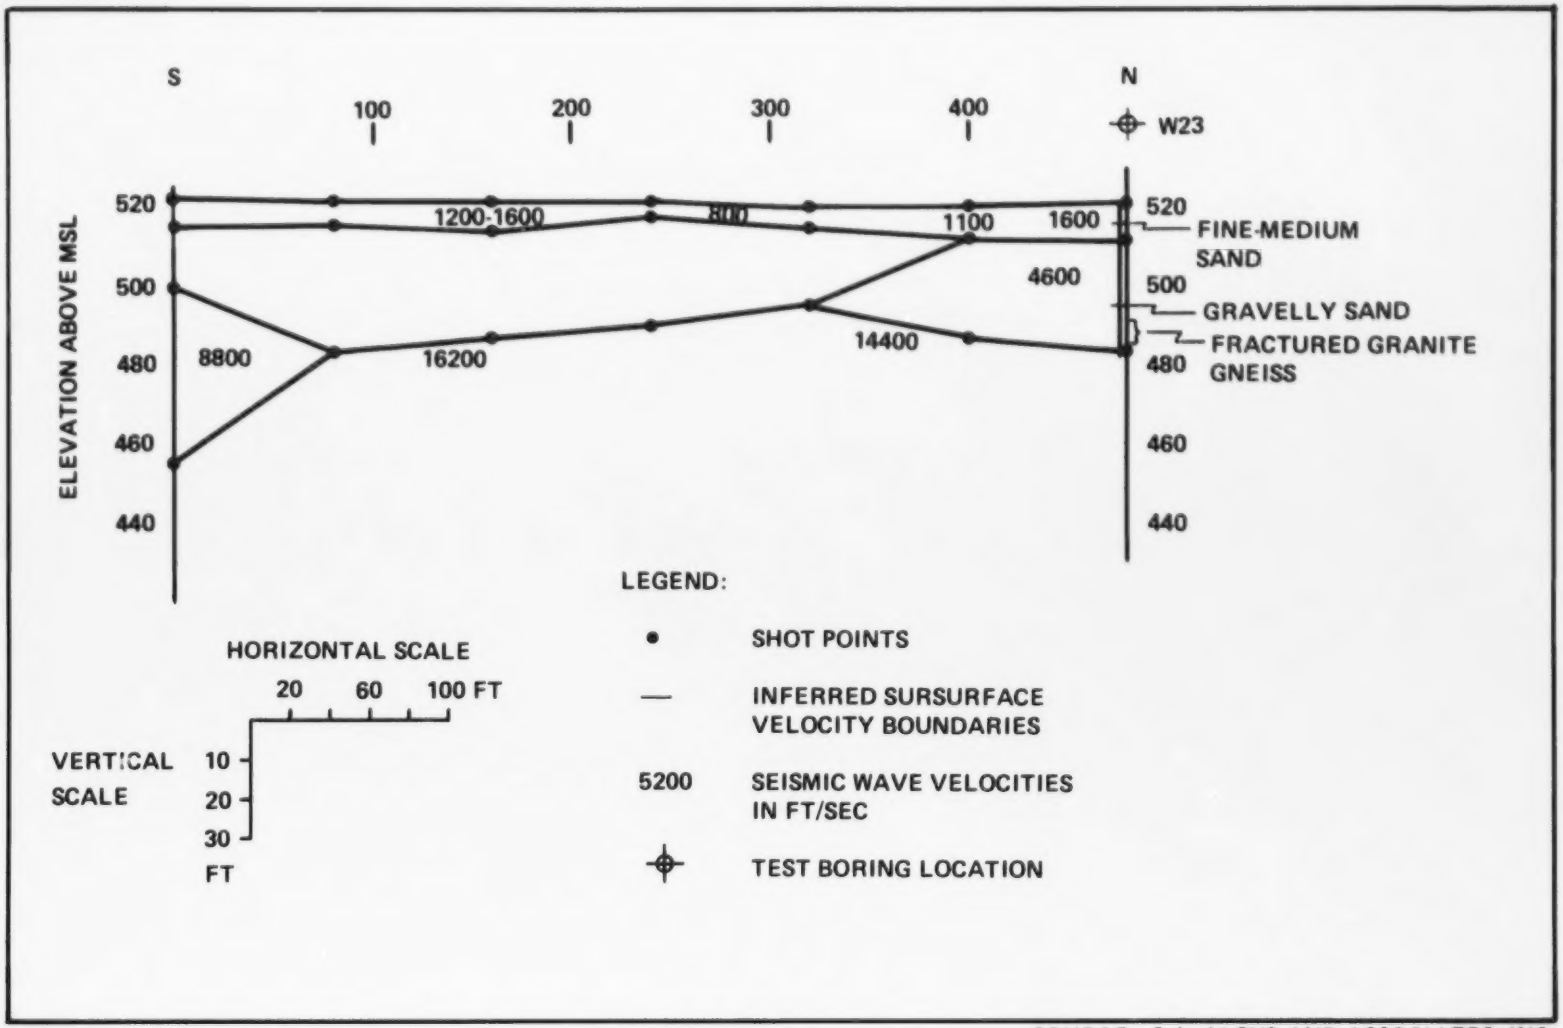
Figure 11. Results of Seismic Refraction Survey: Line 4
(Ground surface represented by top line of figure)

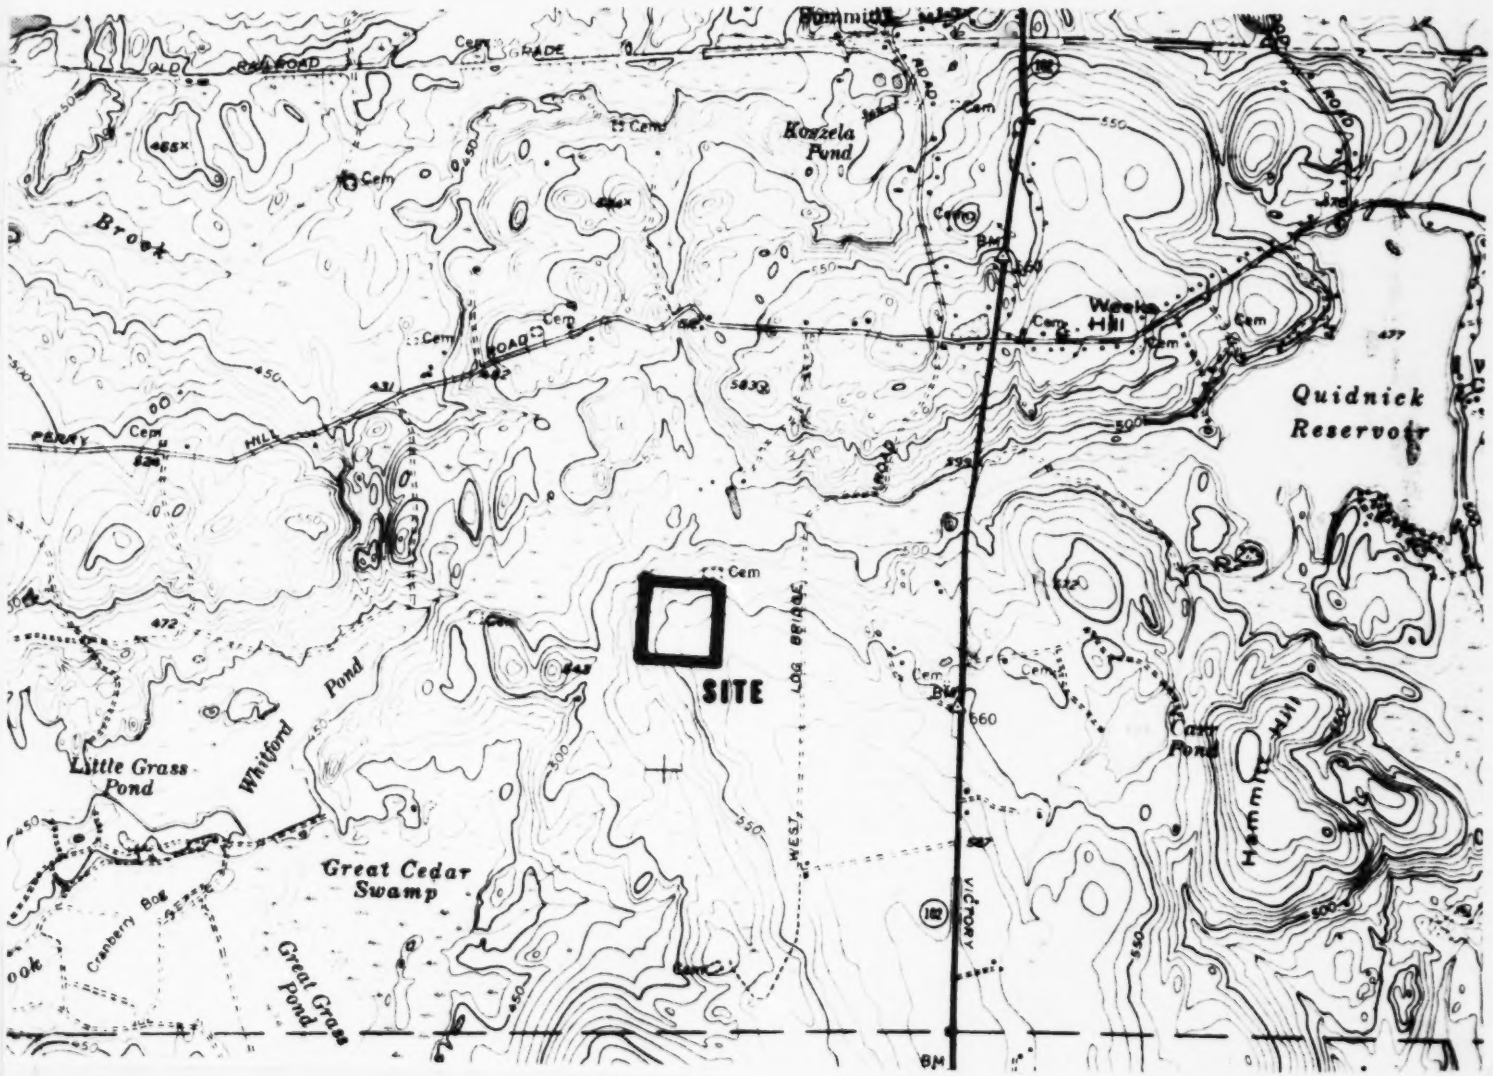
Figure 12. Topographic Map of Region Around Picillo Property

The EPA additionally sampled a stream which would be the potential route of pollutants from the dump site to Quidnick Reservoir. The sampling station is located on Victory Highway, approximately 2000 ft south of the Perry Hill Road Intersection (see Figure 12). None of the organic constituents shown in Table 14 (the sample was not analyzed for inorganic constituents) were found to be present. As in the case of the inlet to Whitford Pond, this stream should be periodically monitored to protect against the possibility that the pollutant migration may be more extensive than the ground water map indicates.
